**ART End User Applications
Task 2.04.19.06
Supercritical Transformational Electric Power (STEP)**

Milestone Report

Foil Bearing Coating Behavior in CO₂

August 1, 2017

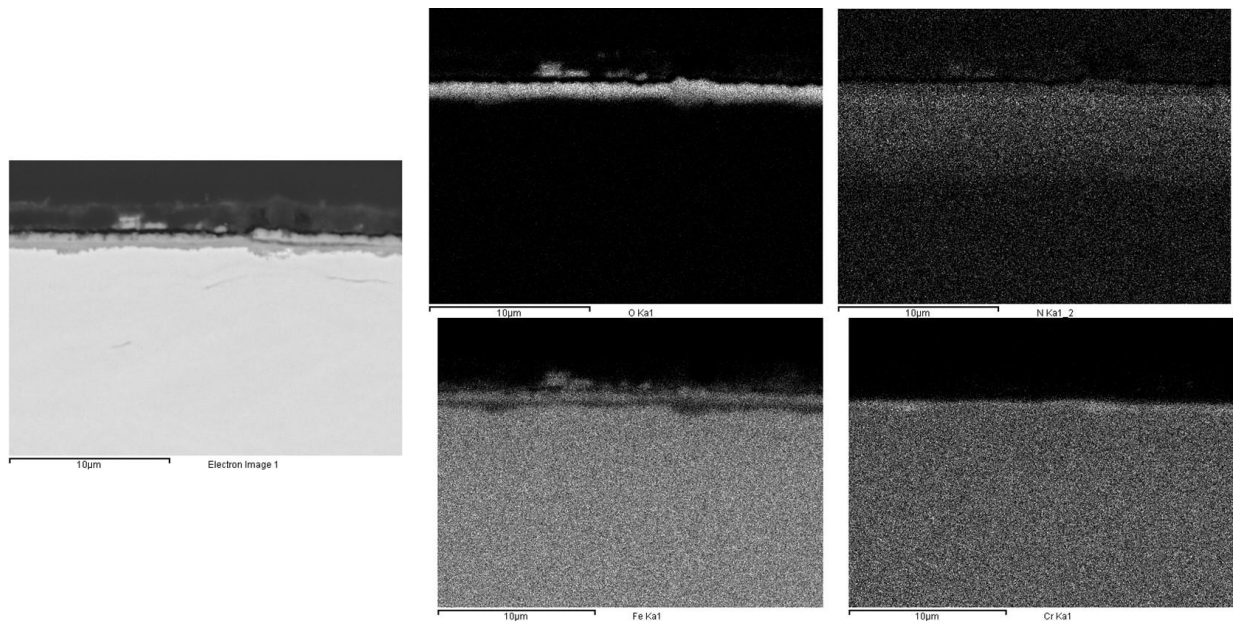
Figure 26. EDS chemical analysis for the TX1 coating exposed at 315°C

Some samples exhibited extensive microstructural damage, which may preclude them from future consideration/testing as a bearing foil coating material. For the 315°C environment, the analysis suggests that the TX1 samples be eliminated from consideration. Chemical analysis of the corrosion products on the TX1 material is shown in Figure 26. While the nitrogen is still found near the surface and may be able to impart the desired hardness and wear resistance, an iron-based oxide is found on the surface that could spall and contribute to particulate generation within the bearing. The baseline thrust bearing coating also exhibited severe microstructural damage at the lower temperature. This may be attributable to a testing temperature above that which the bearing actually sees, since the degradation observed in this test was much more severe than is typically observed for these bearings. Nonetheless, it is good to know that other bearing coating materials are available that can tolerate this 315°C exposure temperature without the same degradation.

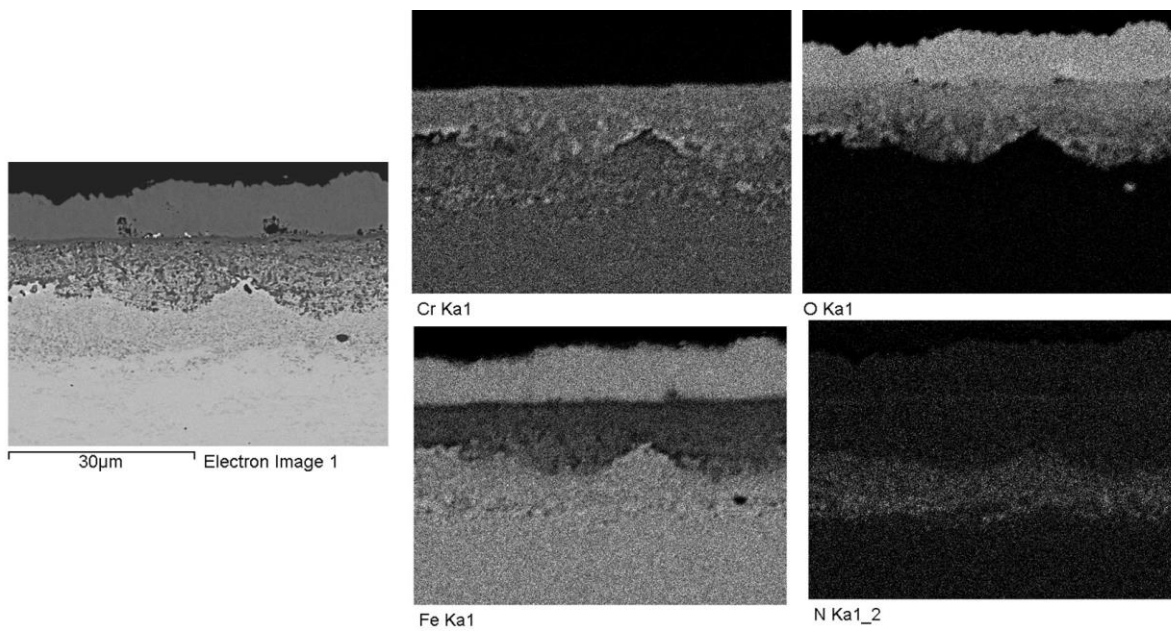
Figure 27. EDS chemical analysis for the TX1 coating exposed at 550°C

For the 550°C environment, several of the samples could be eliminated from consideration based on the severity of the microstructural damage observed. The TX1 sample oxidation, that was a problem at the lower temperature, was even more problematic at this higher temperature. Chemical analysis of the corrosion products on this sample are shown in Figure 27. The oxide is now much thicker and consists of an inner chrome-oxide layer and outer iron-oxide layer. This material should be eliminated from consideration in bearing foils at both of the exposure conditions. Also, the 10K2 coating is not recommended for use at this temperature due to coating delamination from the foil substrate. Chemical analysis of this coating is shown in Figure 28. The substrate surface was observed to be depleted in chromium, as a precipitated Cr-S phase was found within the Ni-P coating layer. This may have contributed to the coating delamination that was observed. Also, islands of a Ni-S phase were found on top of the coating surface, which may contribute to increased surface roughness.

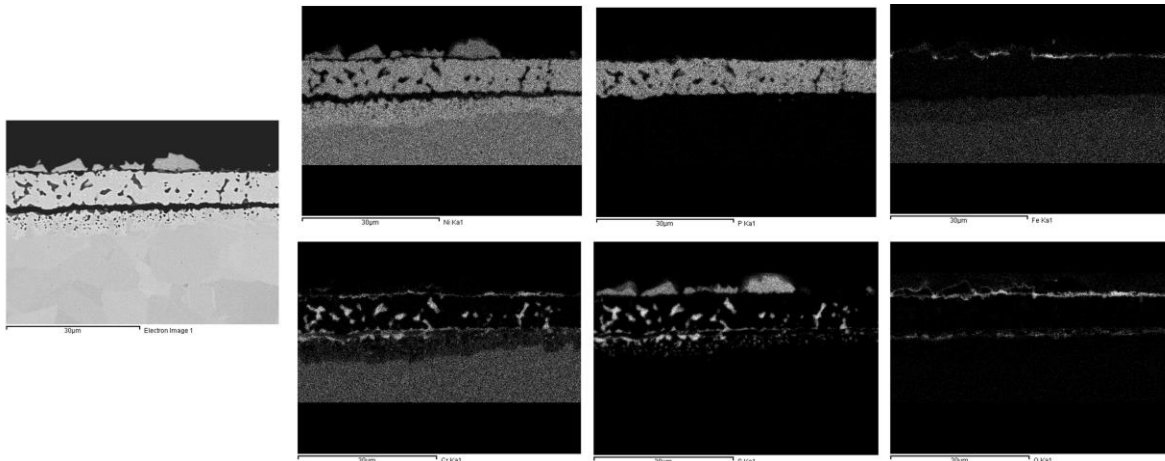
Figure 28. EDS chemical analysis for the 10K2 coating exposed at 550°C

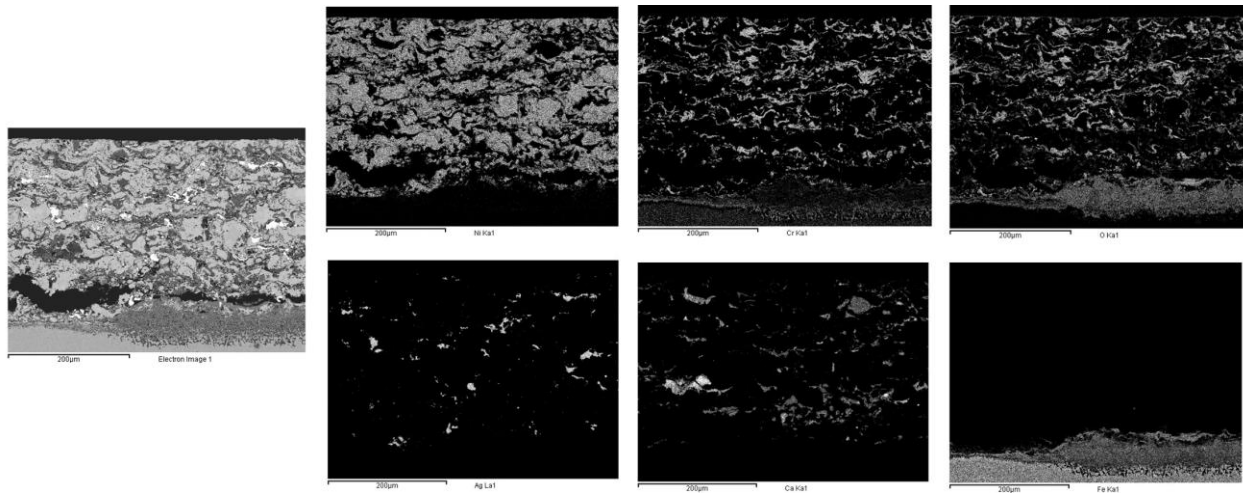
Figure 29. EDS chemical analysis for the PS400 coating exposed at 550°C

Microstructural degradation was observed for both the PS400 as well as the Mechanical Solutions samples (A39, A40, A42) at the higher temperature, but neither should be precluded from future consideration based on this. In the case of the PS400, the coating material itself did not change. Instead, oxidation was observed to occur at the coating-substrate interface. A chemical analysis of the coating-substrate interface is provided in Figure 29, which shows the formation of iron-oxide at the interface. This is partially attributable to the substrate material, rather than to the coating. The PS400 was applied to a 15-5 stainless steel substrate, which is significantly more susceptible to corrosion in CO₂ environments than for the Inconel X750 substrates used with many of the other coatings. One could argue that the MoS₂ or WS₂ samples, which also did not exhibit obvious degradation of the coating material, would have demonstrated similar substrate oxidation as the PS400 if they had been put down on the 15-5 alloy rather than X750.

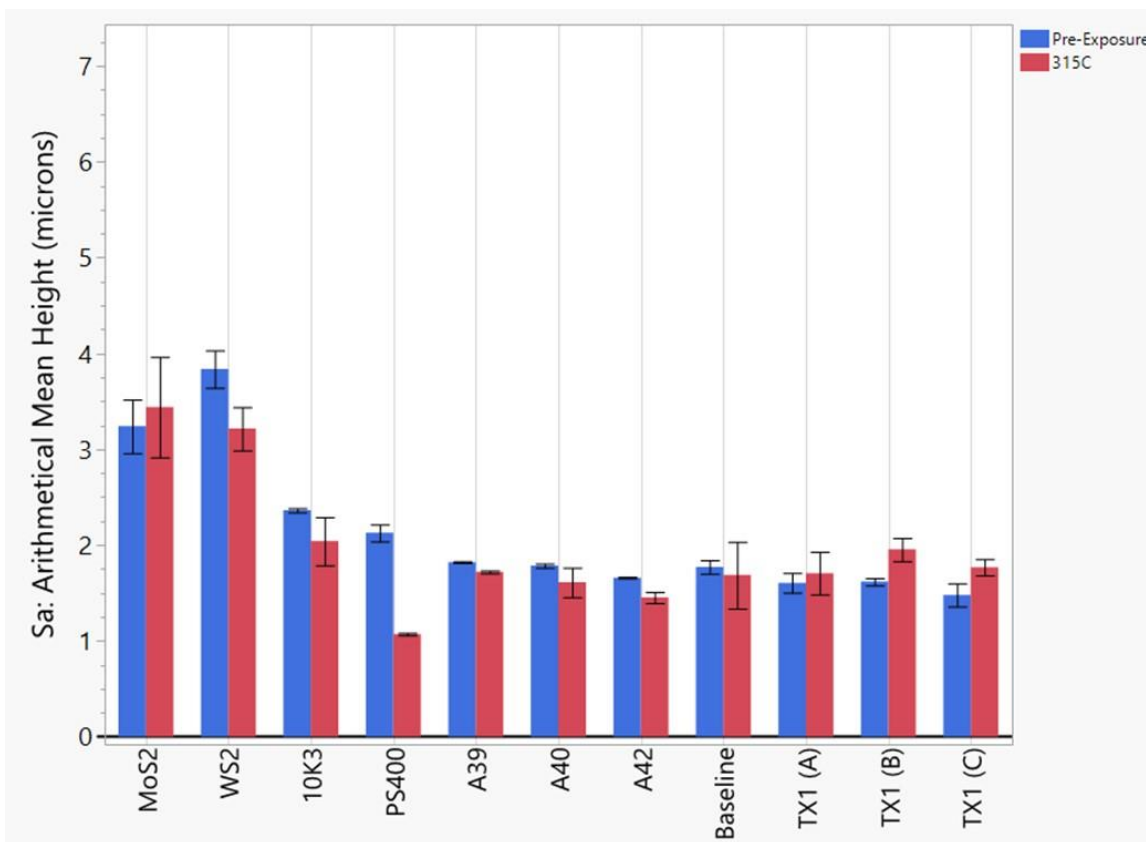
Figure 30. Surface roughness measurements for the 315°C exposure test samples

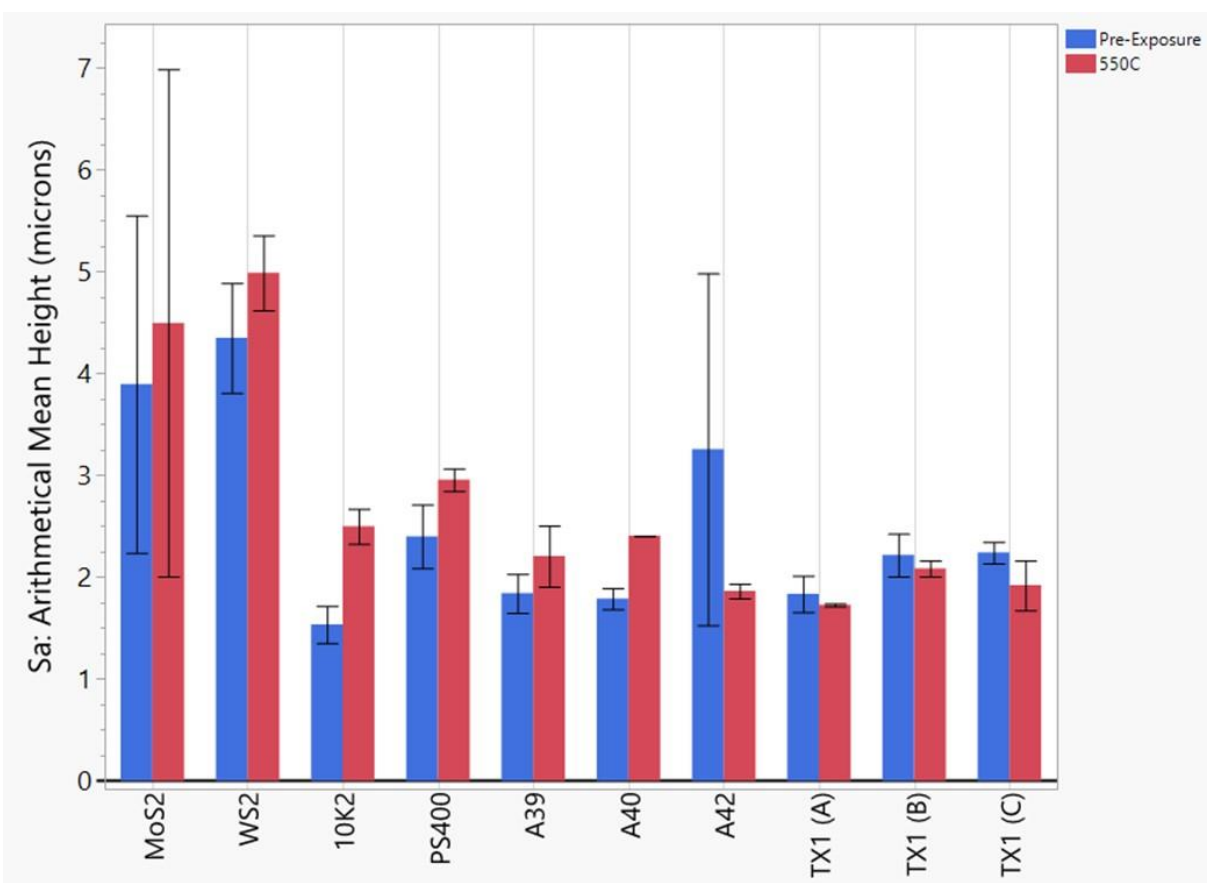
Figure 32. Surface roughness measurements for the 550°C exposure test samples

Surface roughness values for the samples in the 550°C experiment are shown in Figure 32. Again, the MoS₂ and WS₂ samples are identified as having the highest surface roughness. Also, both materials are observed to have increasing surface roughness following the environmental exposure. In fact, most of the candidate materials exhibited increased surface roughness following the exposure, and the surface roughness values are higher than those from the lower temperature exposure. It is unclear what contributes to these trends, but future bearing-rig tests should be valuable to explore this in more depth.

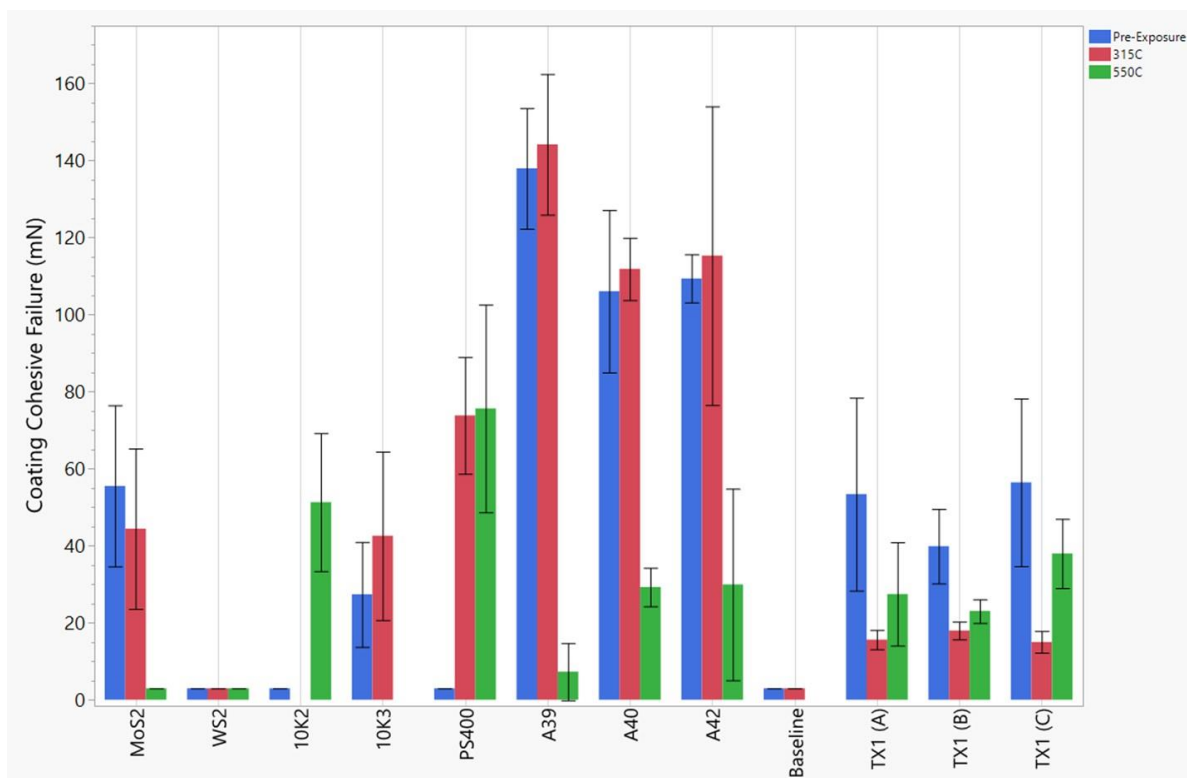
Figure 33. Measured cohesive failure values for each coating material at all exposure conditions

The measured values for cohesive failure are provided for all of the coating materials at each of the test conditions (Pre-exposure, 315°C, and 550°C) in Figure 33. The WS₂ and Baseline thrust bearing coatings were the easiest to damage, and neither changed much with the environmental exposures. A legitimate concern for these samples would be the easy removal of the coating material from the bearing during rubbing. Some samples exhibited high damage resistance prior to exposure, but significantly lower resistance after exposures. This is particularly true for the MoS₂ and the three Mechanical Solution coatings (A39, A40, A42). For these samples, the changes in damage resistance were modest at the 315°C exposure, but decreased significantly at the 550°C exposure. For other samples, the damage resistance was low initially, but showed significant increase after environmental exposure. Obviously, this is preferable to the opposite scenario. This was observed for the 10K2, 10K3, and PS400 samples.

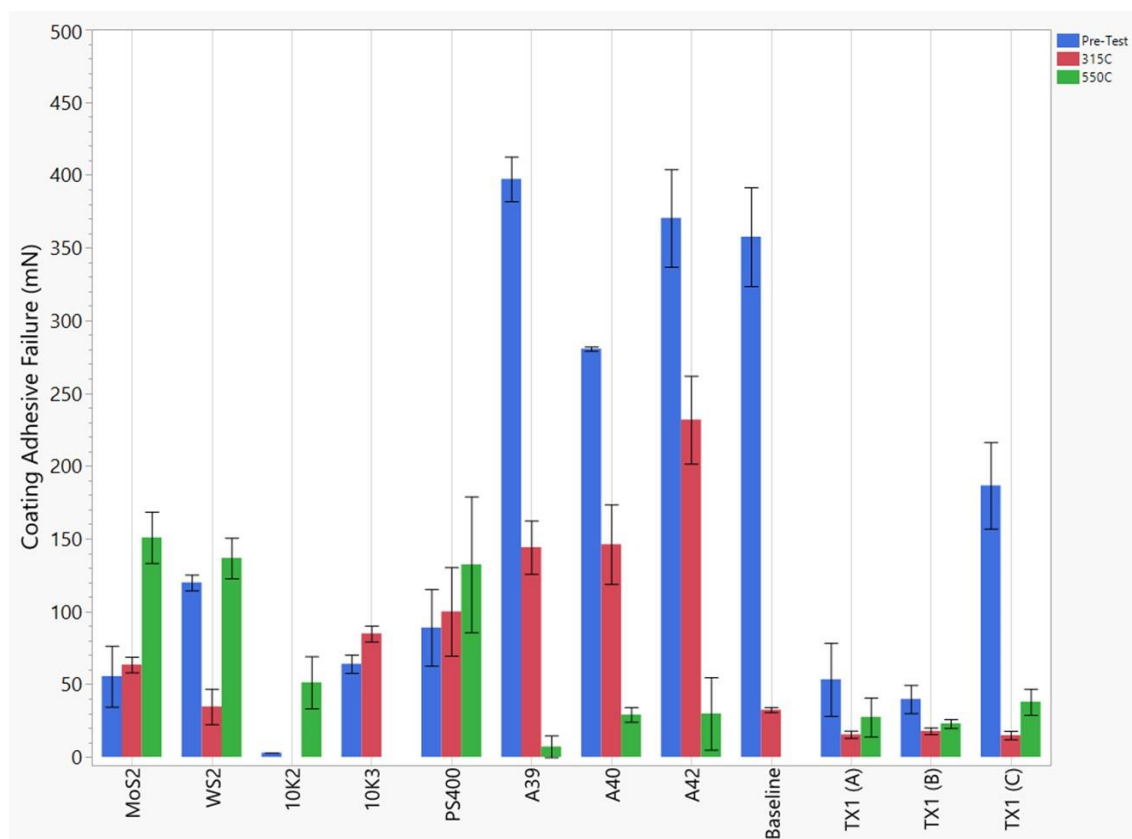
Figure 34. Measured adhesive failure values for each coating material at all exposure conditions

Measured values for adhesive failure are provided for the same coating materials at the same three test conditions in Figure 34. Similarly, to the cohesive failure values, two divergent trends are observed. For some of the samples, the coating adhesion was largest pre-exposure, and decreased with the environmental exposures. This was observed for the three Mechanical Solutions samples (A39, A40, A42), the Baseline thrust bearing coating, and the TX1 samples. Most dramatic among these were the Mechanical Solutions and Baseline samples. These started out with the best coating adhesion strengths, but dropped to some of the lowest values of any following the exposures. For the Mechanical Solutions coatings, the adhesion strengths were higher than any of the other materials following the 315°C exposure, but were some of the lowest values following the 550°C exposure. Samples exhibiting the opposite trend of increasing coating adhesion strength with environmental exposure, were the MoS₂, WS₂, 10K2, 10K3, and PS400 samples.
